# The Alaskan Way Viaduct & Seawall Replacement Project

## Repairs to Foundations Between Columbia Street and Yesler Way

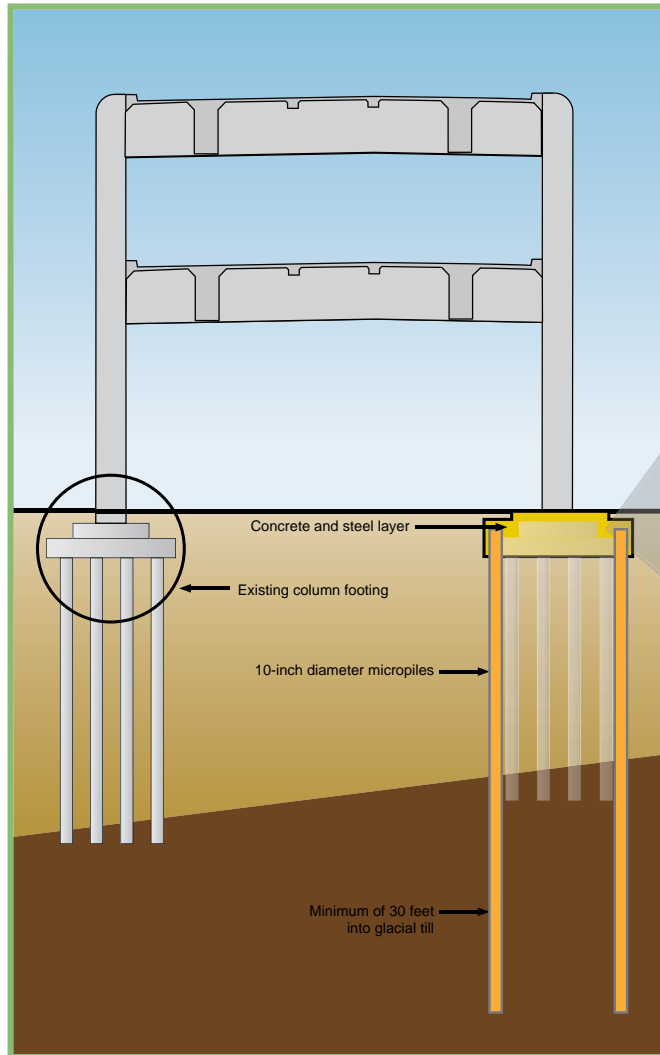
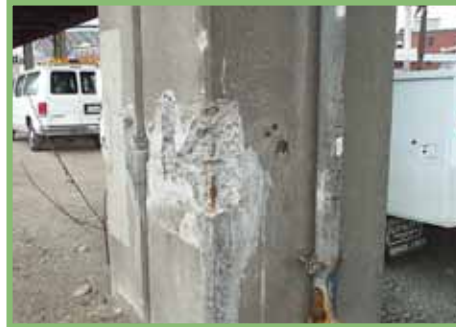
Column footings are not visible above ground.

Micropiles

Existing viaduct column footing

- Strengthen the footings to prevent further sinking into the soil
- A series of micropiles, which are steel and concrete rods, will be drilled into stable soil
- Additional reinforcing layer of steel and concrete will be placed around existing footings
- The work will begin in 2007 and take five to six months to complete
